# SERVICE BULLETIN

from: TRIO-KENWOOD COMMUNICATIONS, INC.

SUBJECT: TS-520S -6V DC SUPPLY FAILURE

DATE 8/9/79

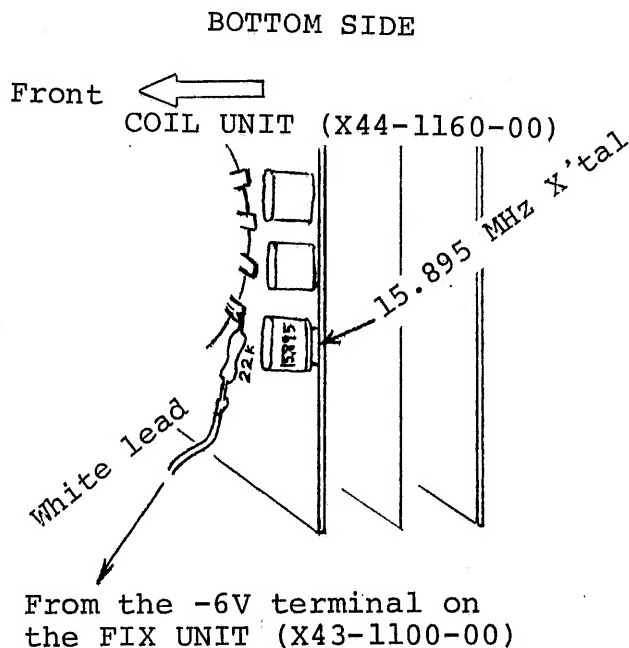
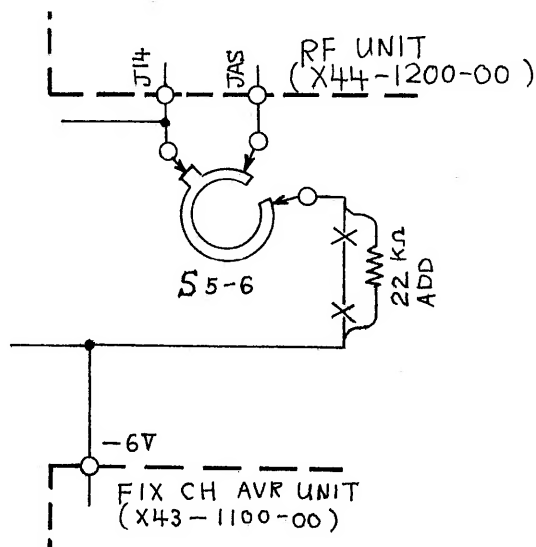
When troubleshooting a TS-520S, check all power supply voltages, including the -6V DC supply. Symptoms such as dead, blown 2A DC fuse and now dead, low RX, no TX, or similar may occur after switching between 80 & 40M.

Cause of failure may be traced to an intermittent shorting between the 14V DC & -6V DC supplies as the Band Switch is rotated between 40 & 80 M. This will weaken or destroy D8, 6V Zener on the FIX CH AVR unit. To prevent repeat failure, break the WHITE lead & install a 22K ohm  $\frac{1}{2}$ W resistor at the Bandswitch S5-6, between the -6V supply line and switch terminal. And of course replace D8 on the FIX CH AVR unit, X43-1100-00.

New Part 22k ohm  $\frac{1}{2}$ W
